45 West Newton Street South End Landmarks Commission

**Design Review
January 2, 2019**

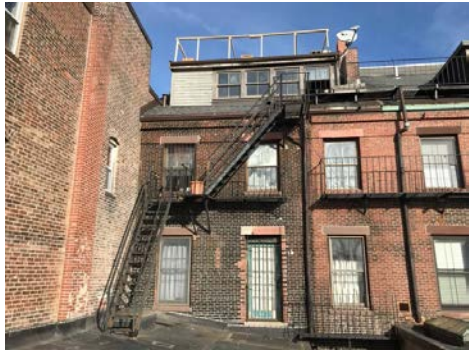
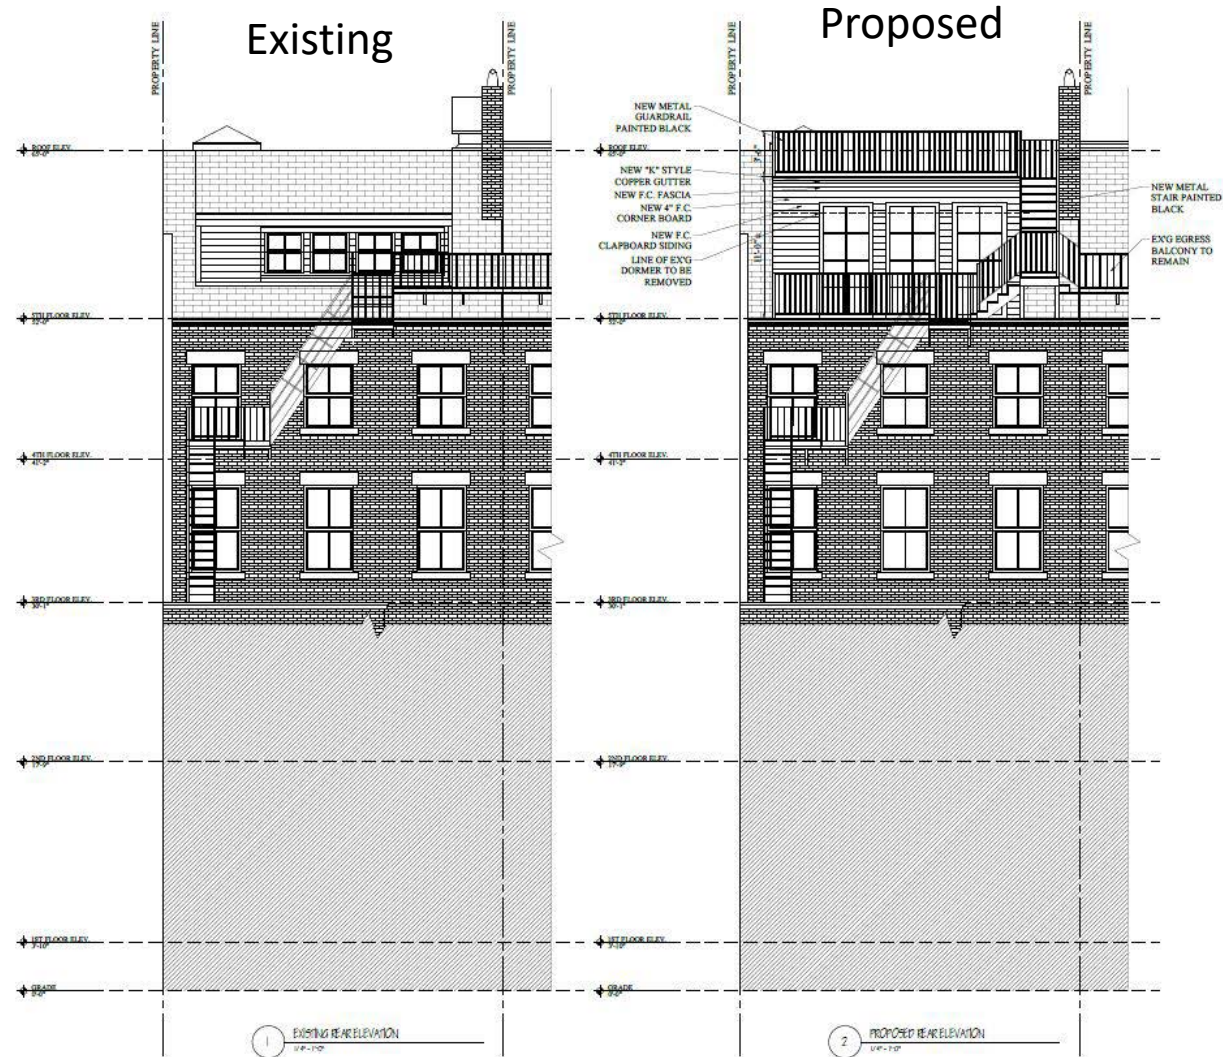
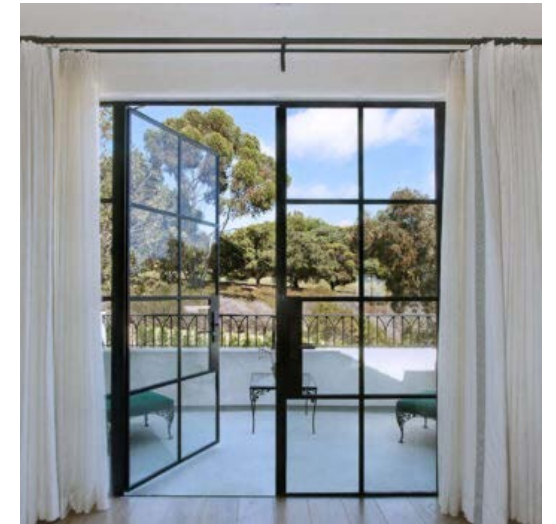
Rear Elevation

- Reconfigure the existing rear dormer
 - Bring the dormer back an additional two feet from the rear of the building, aligning with adjacent buildings
 - raise the edge of the dormer to accommodate desired internal ceiling height
- Relocate roof deck, previously located on the top the building, to the rear dormer

Steel doors like those
by Euroline

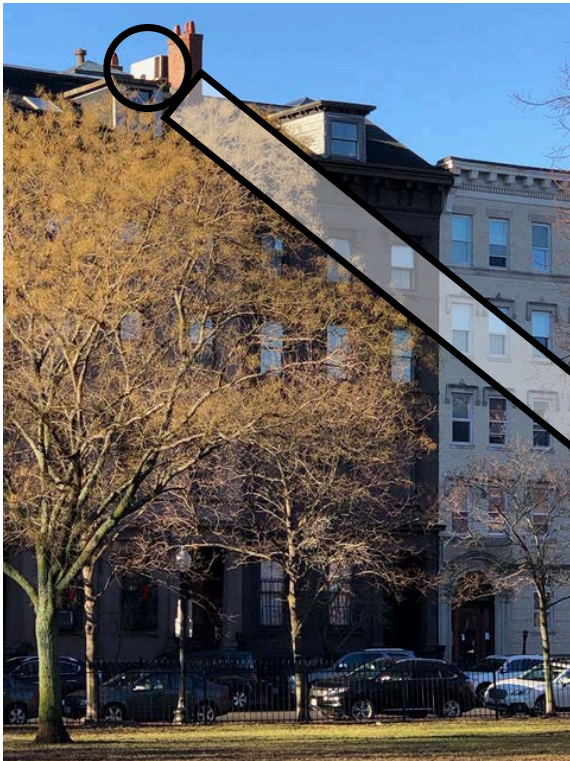
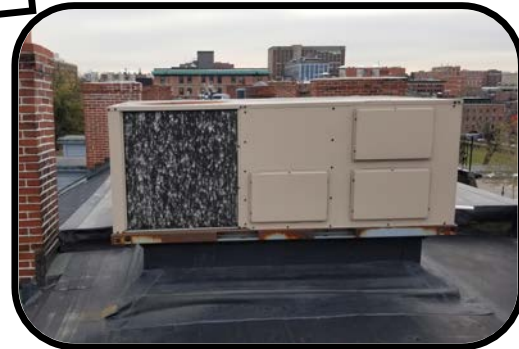
**Front Elevation:
HVAC Mechanicals to be Relocated**

- A large HVAC mechanical unit that currently sits on the top of the building will be removed. A smaller replacement unit will be relocated and no longer be visible from the street
- Two satellite dishes, currently attached to the existing dormer will be removed
- Replace existing dilapidated dormer and small windows with and new new dormers and fenestration that reflects guidance from Commission staff

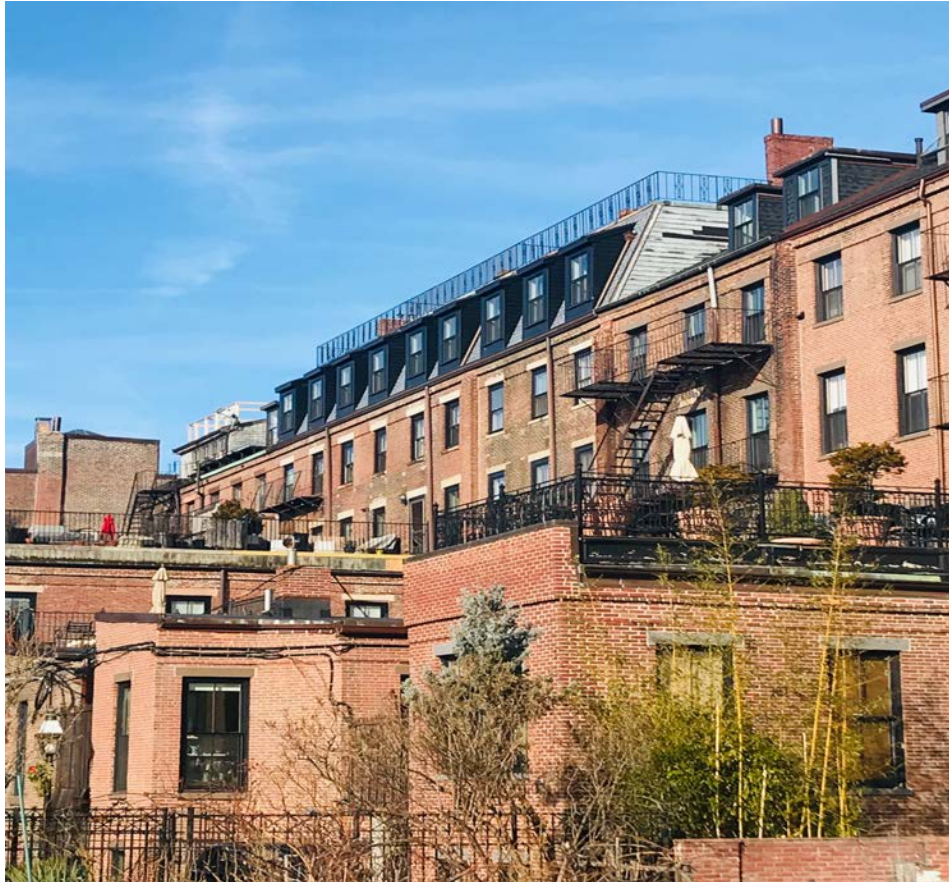
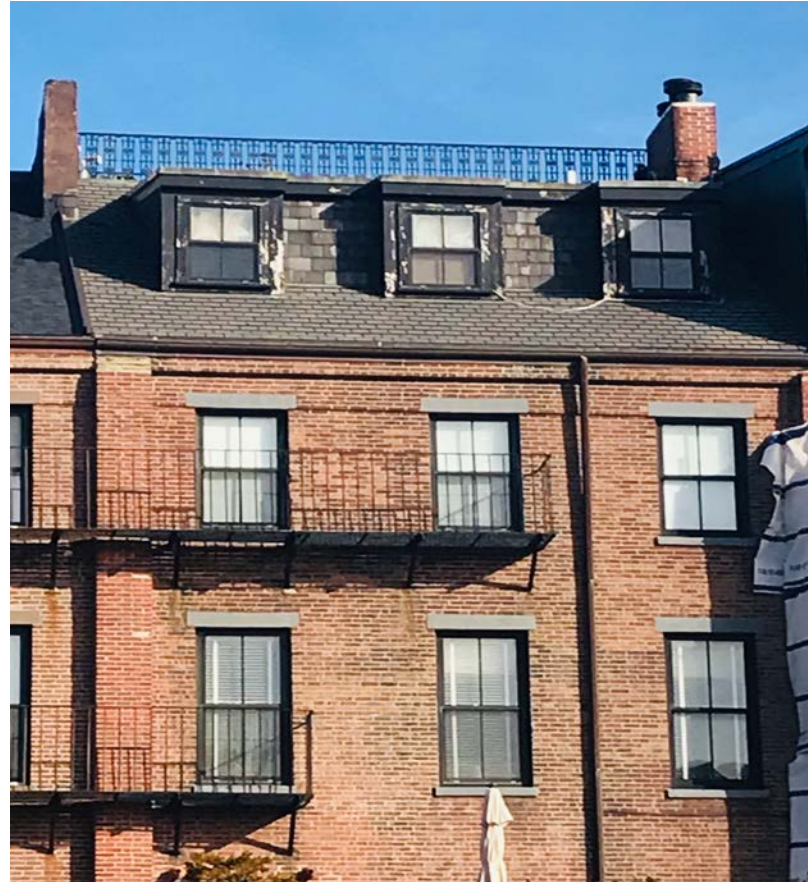
Rear views of West Newton Street

- A wide assortment of dormer treatments exist on the rear of West Newton St. today, with the subject property in the worst condition, but also furthest from view
- There are numerous roof decks on the rear and tops of adjacent buildings
- Decorative rooftop ironwork has been a feature of buildings on this block since they were originally constructed in the mid-19th Century
